Power Survey™ in Palmdale, California

Osmose Helps California City Identify Energized Streetlights Before Harm is Done

Osmose - Palmdale Detailed Report

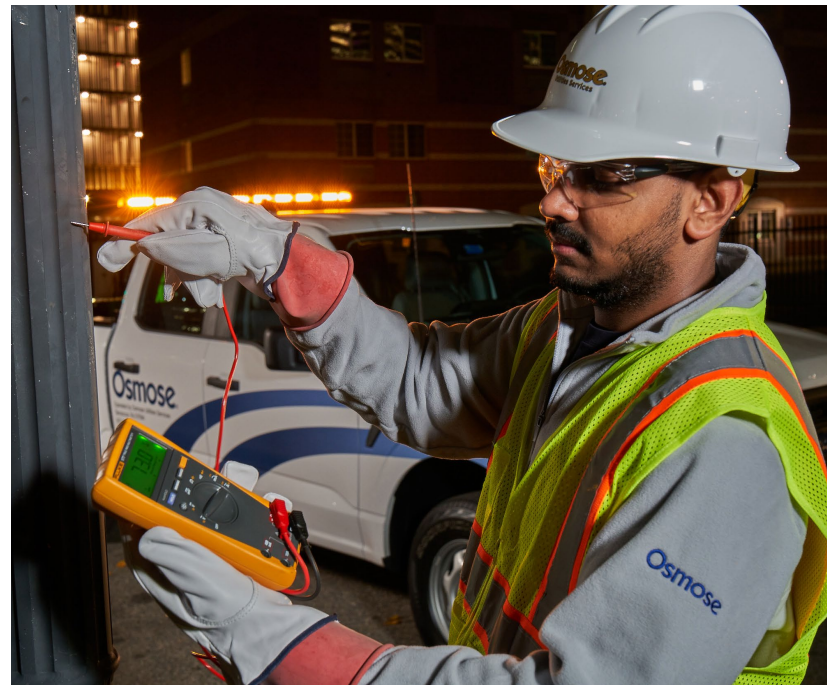
Whatever caused the burnout also energized the streetlight, which could severely shock people and pets upon touch. Where else might this hidden hazard exist?
